## Gel-Coat Blistering for RV Filon® Sidewalls

**Also known as: Osmotic Blistering or Gel-Coat Chipping or Popping**

Form 65140 | Rev. 1 | 9.10 | (5552) Noble and Filon are registered trademarks of Crane Composites, Inc.

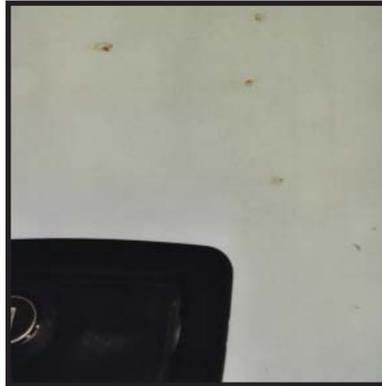
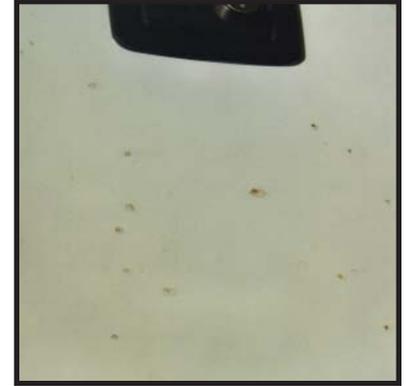
The occurrence of gel-coat popping/chipping/blistering is caused by the long-term presence of water to the backside of the fiberglass panel. When the lauan plywood substrate is saturated with water, capillary action moves the water through the fiberglass panel. The movement of the water through the panel continues until it hits the impervious gel-coat outer surface of the panel. Pressure builds behind the gel-coat layer as the trapped water is exposed to various hot and cold cycles. Gel-coat popping/chipping/blistering occurs when the built-up water pressure is greater than the bond of the gel-coat layer to the fiberglass substrate.

To eliminate the potential of reoccurrence to the popping/chipping/blistering problem on the panel surface, the source of the water to the backside of the fiberglass panel has to be eliminated. This will require the replacement of the saturated lauan plywood substrate and the correction of how the water is getting to the lauan plywood. Surface repair of the gel-coat popping/chipping/blistering area can be performed once the lauan substrate is dry, and the source of water is eliminated.

1. The source of water that is saturating the wood substrate must be located and eliminated.
2. The saturated wood substrate must be allowed to dry completely before proceeding to the next step.
3. Surface repair of the gel-coat can be done by utilizing the Crane Composites Repair Guide (form #65000), which can be found on the Crane Composites website at [www.cranecomposites.com/RV/maintenancewarranty.asp](http://www.cranecomposites.com/RV/maintenancewarranty.asp)
